# REPORT OF APOLLO 204 REVIEW BOARD

**NATIONAL AERONAUTICS AND SPACE ADMINISTRATION**

Spacecraft 012 was undergoing a "Plugs Out Integrated Test" at the time of the accident on January 27, 1967. Operational Checkout Procedure, designated OCP FO-K-0021-1 applied to this test. Within this report this procedure is often referred to as OCP-0021.

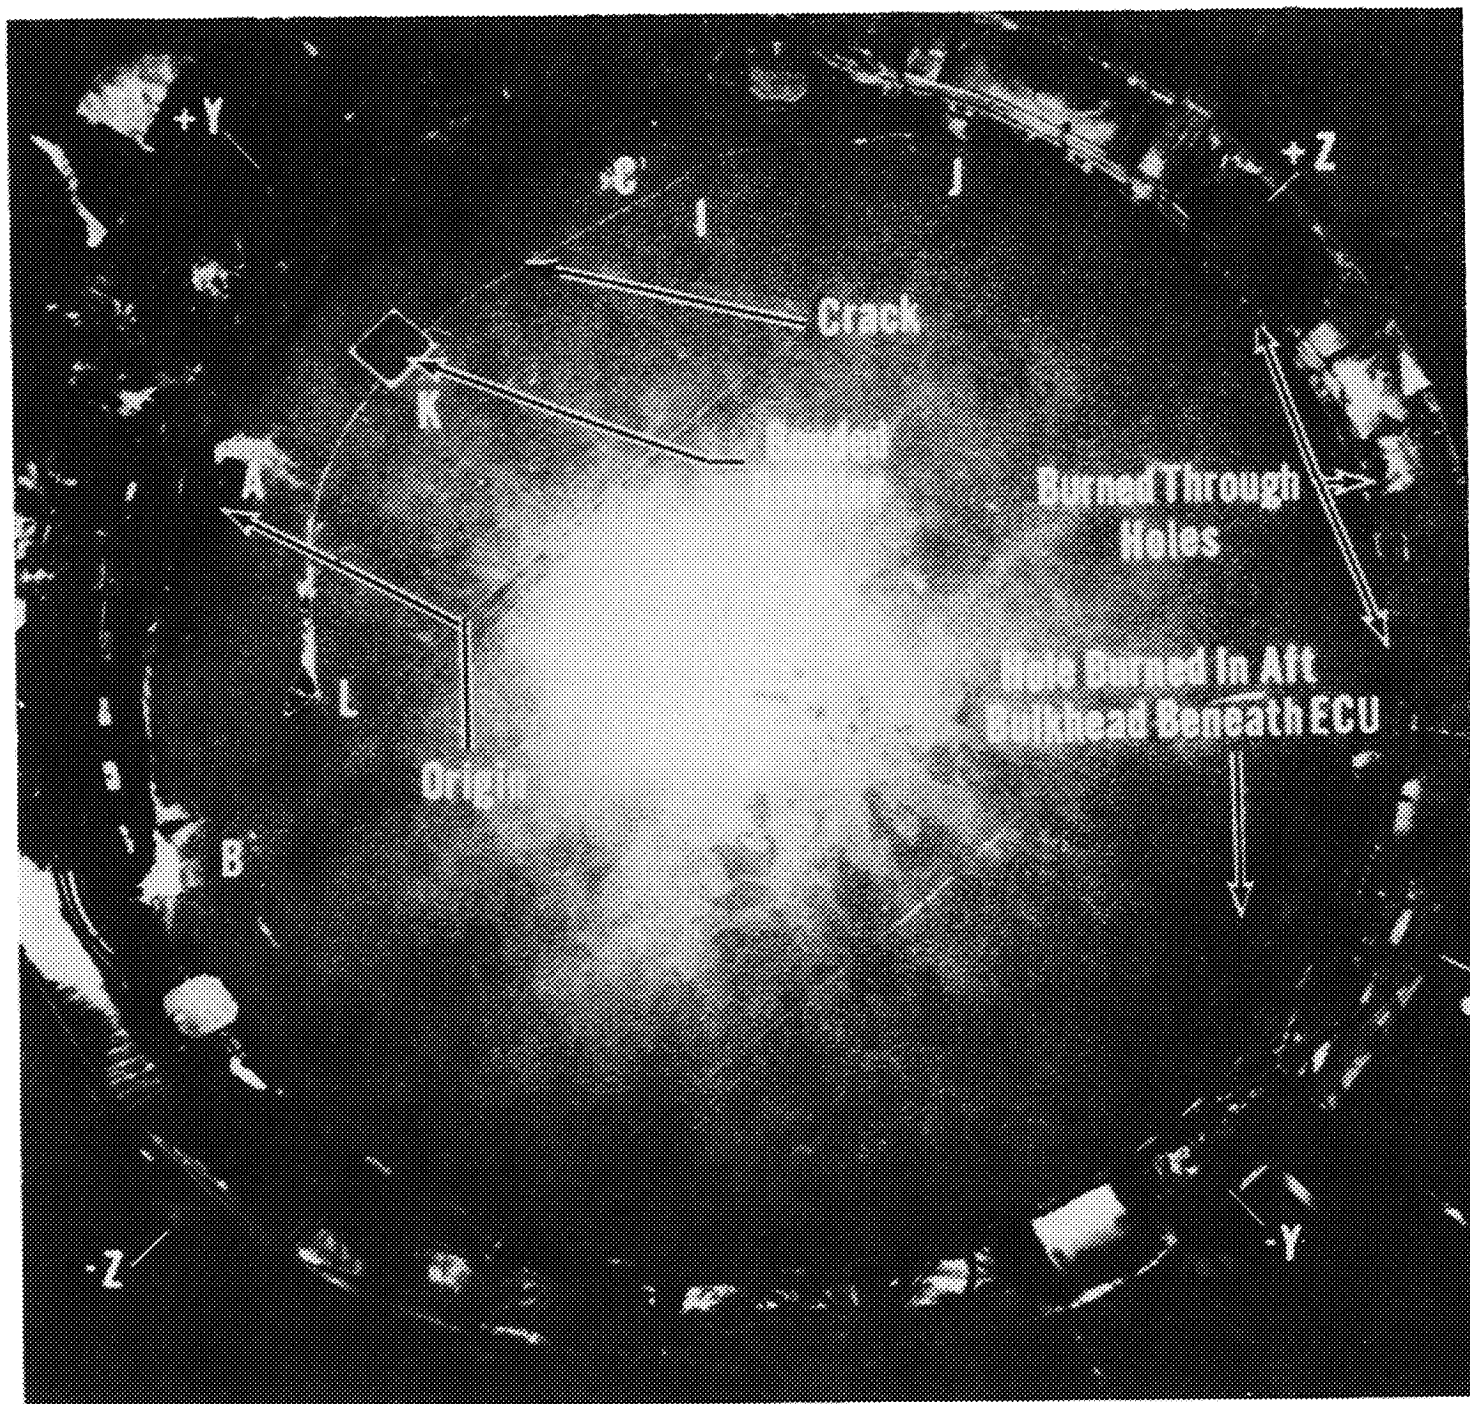
AFT BULKHEAD OF CREW COMPARTMENT
